Capital Needs Assessment

**HAWTHORNE SUITES BY WYNDAM
1628 WEBSTER STREET
ALAMEDA, CA 94501**

**ALAMEDA AFFORDABLE HOUSING CORPORATION
701 ATLANTIC AVENUE
ALAMEDA, CA 94501**

June 1, 2022

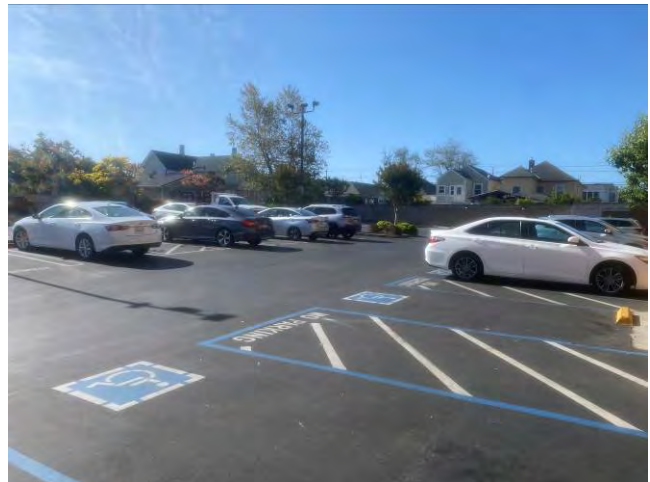
4. Typical condition of asphalt paving.

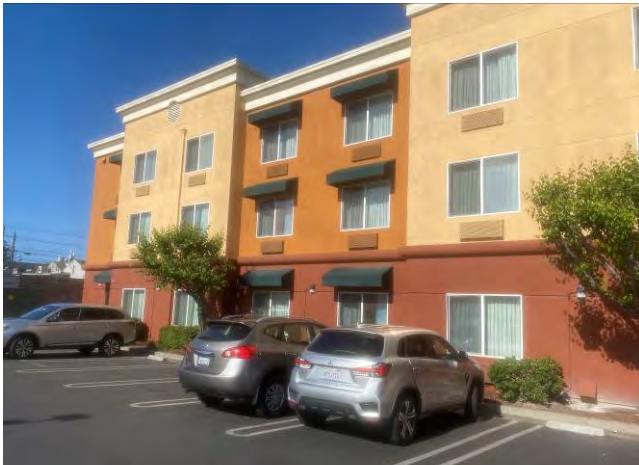
15. Typical exterior stucco conditions, guest room entry and entry to lobby.

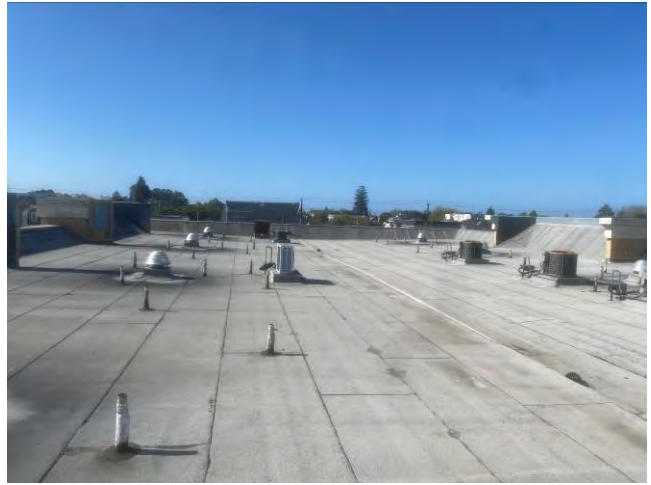
- The original built-up membrane roof is 19 years in age and has required ongoing repairs and partial replacements. Bubbled membrane, worn sealants and mastics and worn cap sheet were also observed. Based on the provided replacement and recoating bids provided by the owner for PPA's review, it is recommended that a full re-roof (tear off, replace damaged substrate, and install new membrane) is recommended. Re-coating seals in existing damage including any substrate damage that may exist and is therefore not the recommended re-roofing method.

20. View across the roof surface showing ventilation fans, sanitary waste vents, air conditioners and overall condition of original roof membrane.

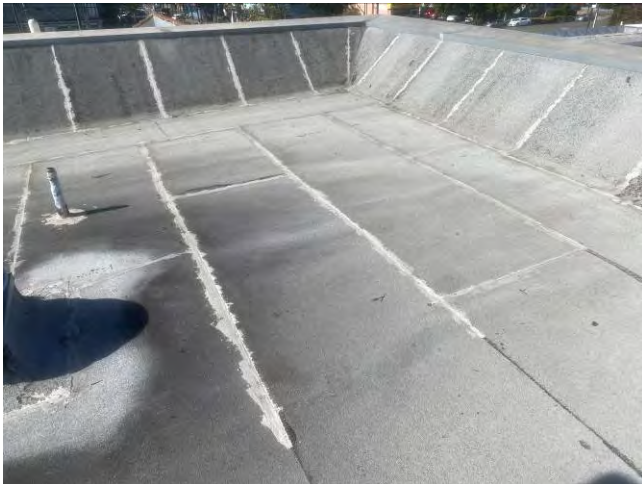
21. Recent roof patches were observed.

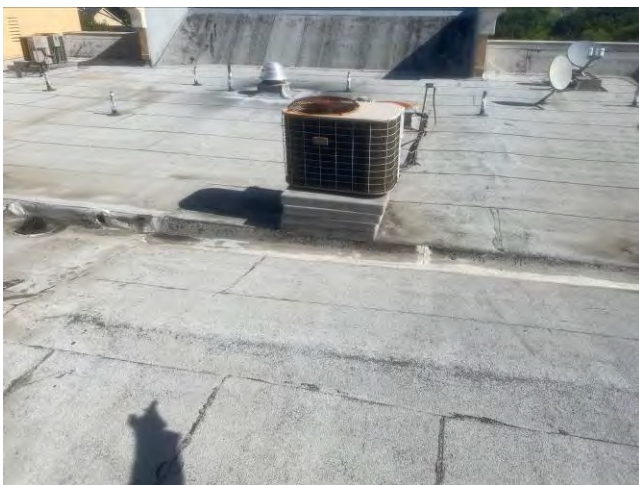
23. Recent roof repair.

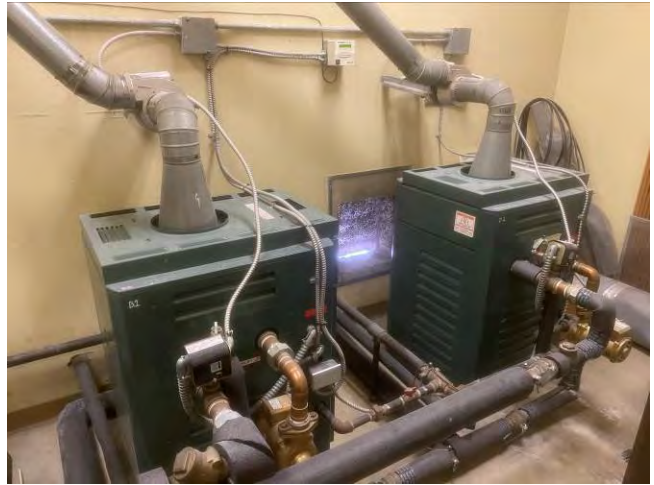
32. Natural gas fired water boilers are original but pumps and fixtures have been replaced as needed.

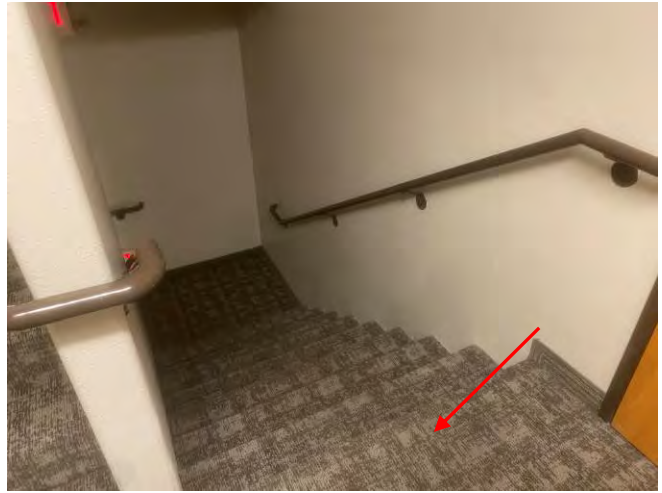
68. Interior stairs, landing and railings. Add contrasting nosings for safety concerns.

- The interior stairs lack contrasting nosings at the landings and treads. The lack of warning stripes presents a safety concern. It is recommended that contrasting nosings be installed at landings and treads.
