Capital Needs Assessment

**HAWTHORNE SUITES BY WYNDAM
1628 WEBSTER STREET
ALAMEDA, CA 94501**

**ALAMEDA AFFORDABLE HOUSING CORPORATION
701 ATLANTIC AVENUE
ALAMEDA, CA 94501**

June 1, 2022

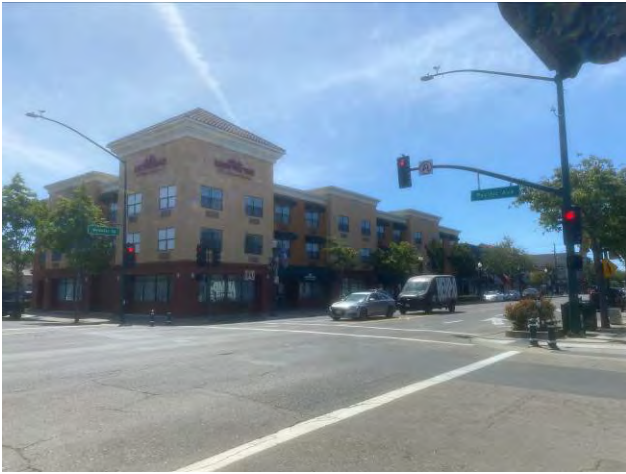
1. View towards Property from across the intersection of Pacific and Webster, view southeast.

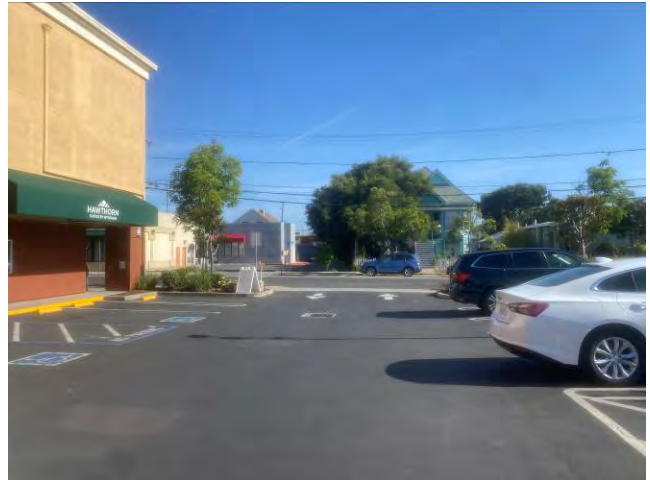
2. Parking lot entrance from Pacific. Note the canopy signage.

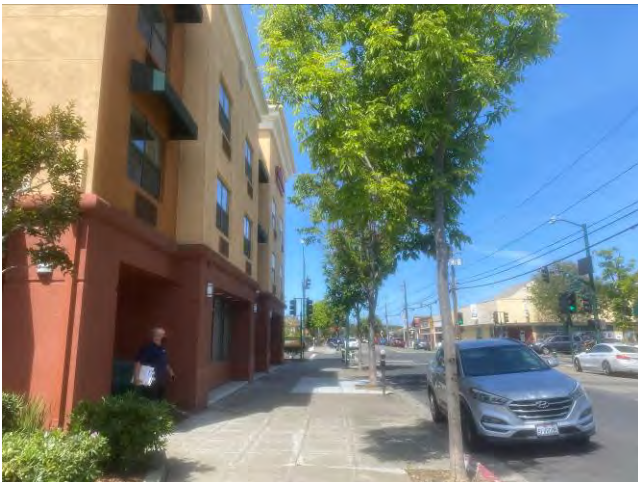
3. Landscaping and municipal walkway typical at the north and west perimeters.

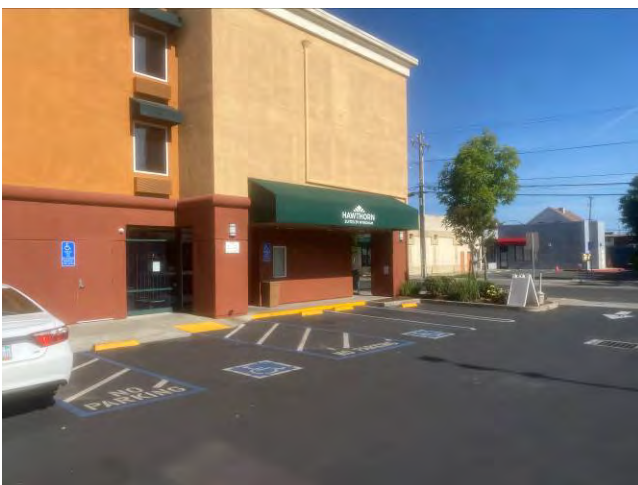
5. Accessible parking stalls at the northeast entrance to the building.

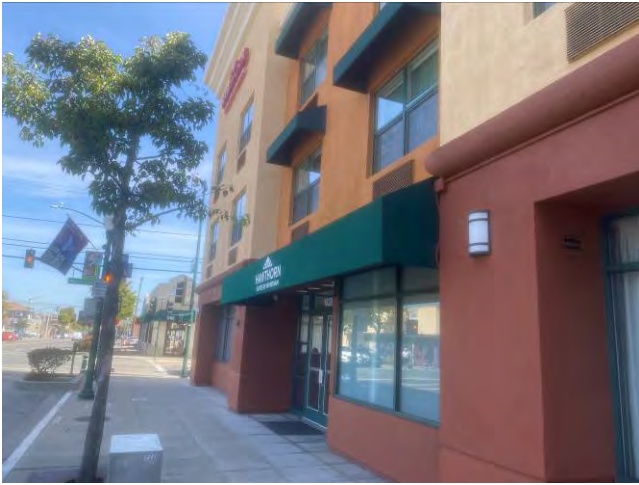
7. Concrete pedestrian walkway at west perimeter entry.

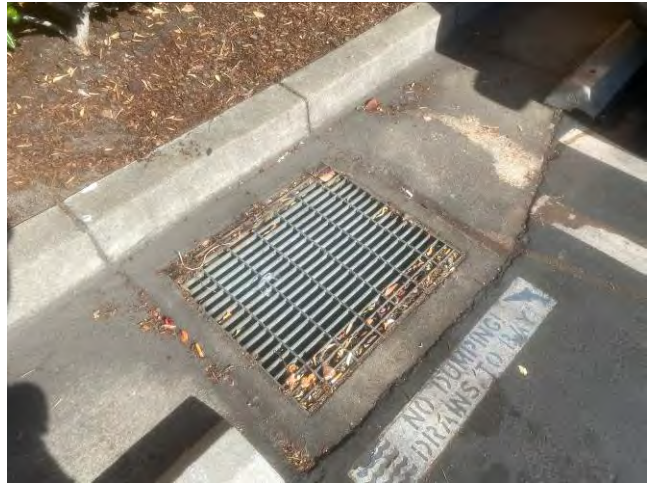
8. Typical storm-drain that connects to the municipal system.

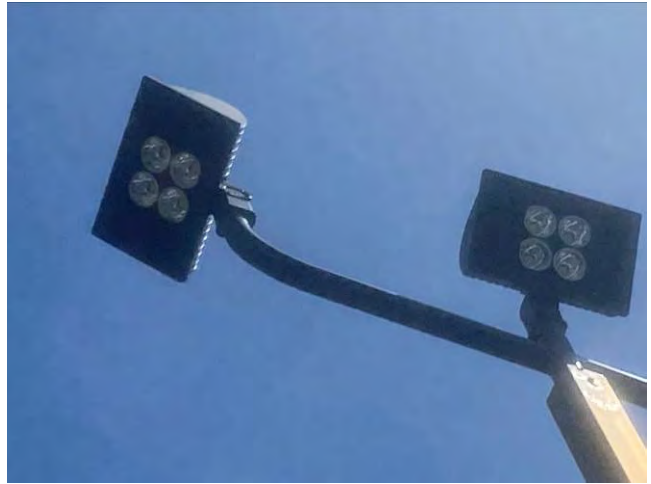
10. LED pole mounted site lighting.

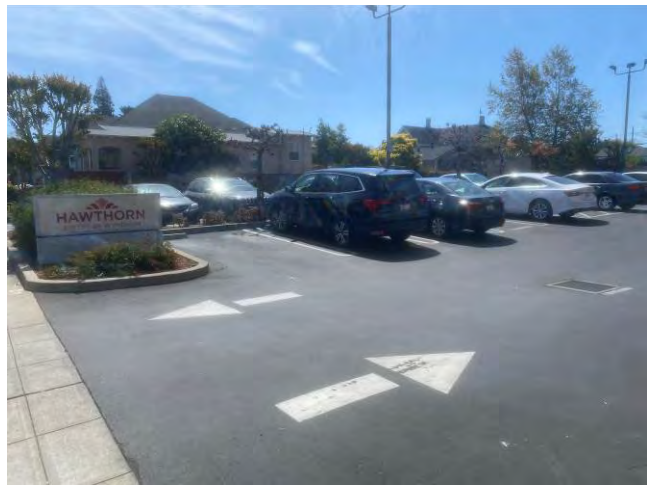
12. Monument signage at north entry drive.

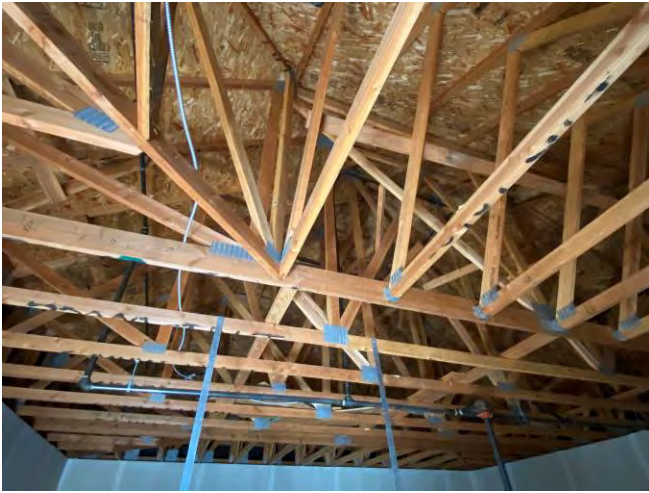
13. Wood roof framing at tower structure on roof.

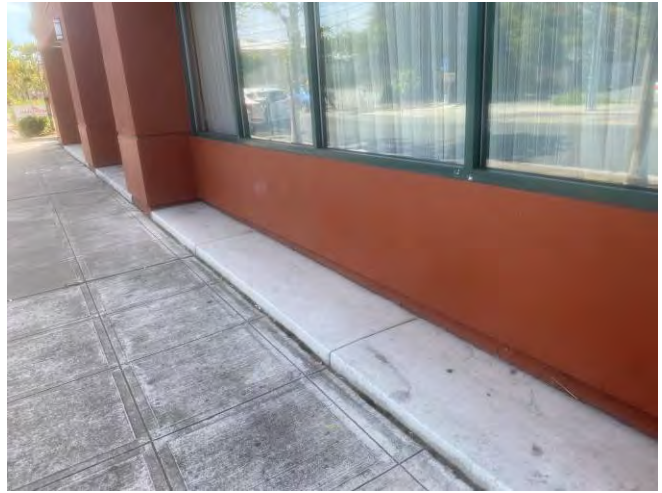
14. The building foundation is reinforced concrete slabs on grade.

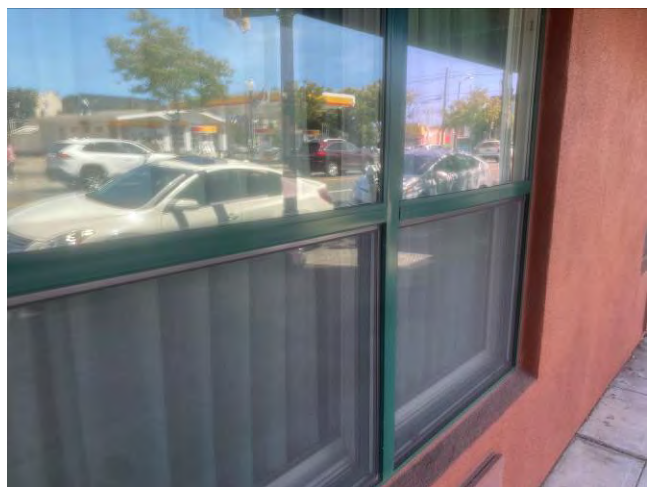
18. A third storm window has been installed at the interior of the street facing windows for sound proofing.

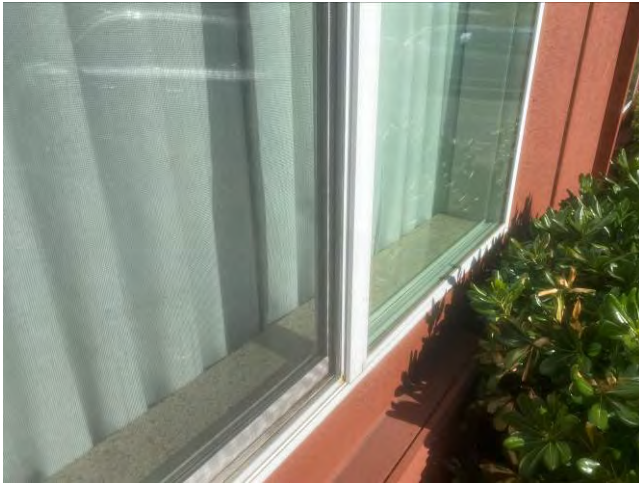
19. Dual glazed aluminum framed sliding windows are installed at some guest rooms.

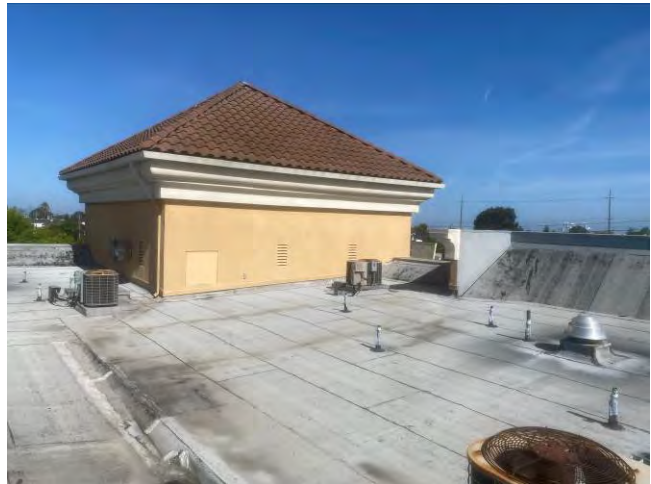
22. Decorative roof tower structure with concrete tile roof.

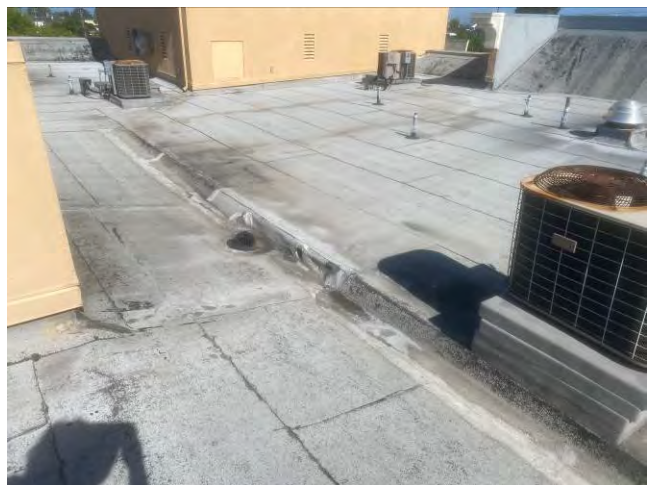
24. Interior drain for roof drainage.

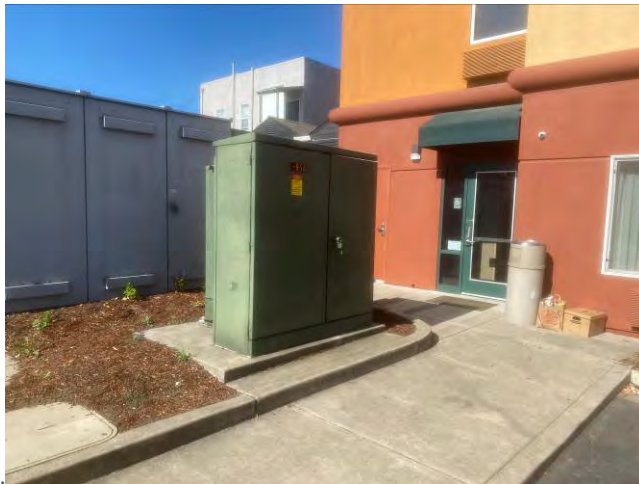
25. Pad mounted electrical transformer.

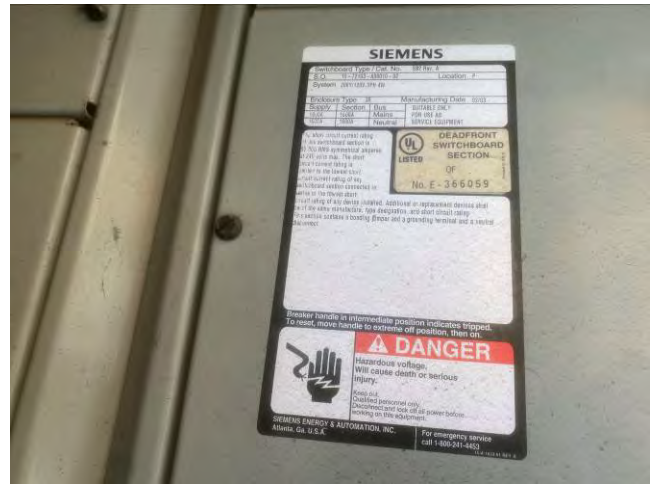
26. Main electrical service is 1600 amps.

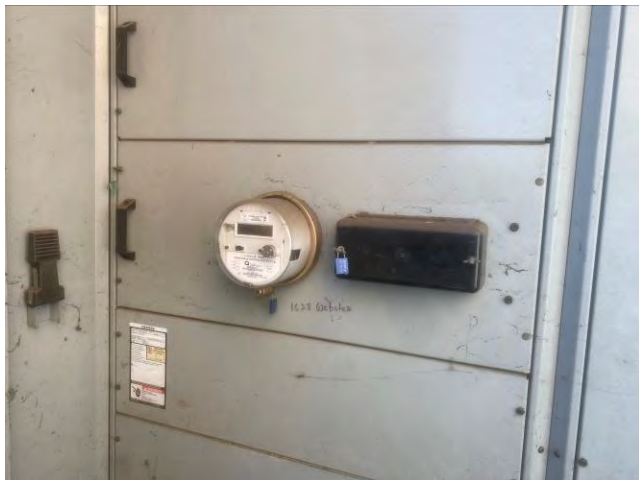
27. Master electrical meter.

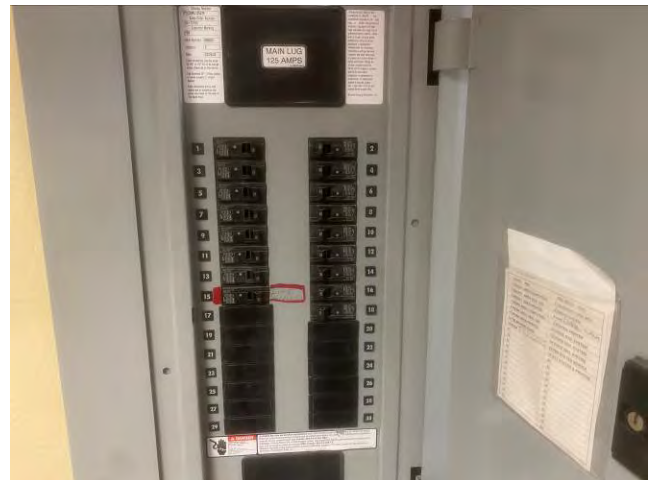
28. Subpanel with circuit breakers and labels.

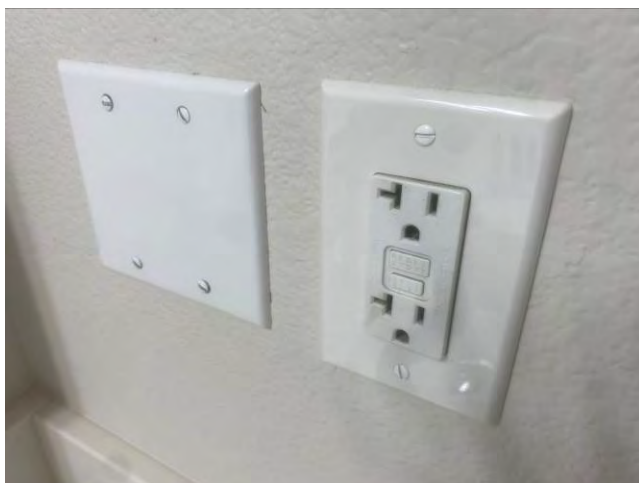
29. GFCI outlets observed in "wet" areas.

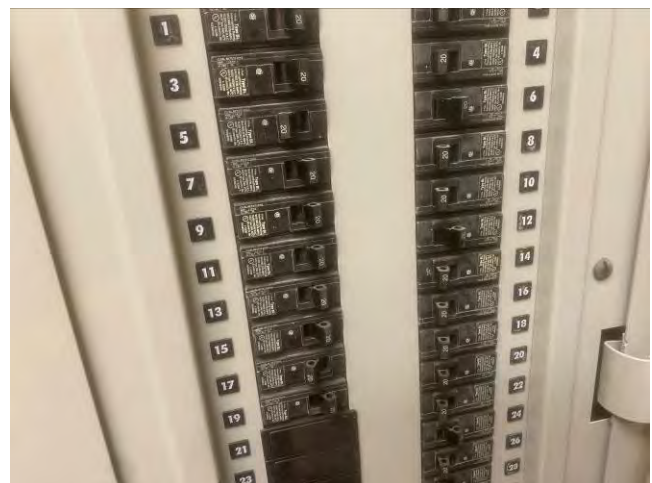
30. 20 amp service to the guestrooms.

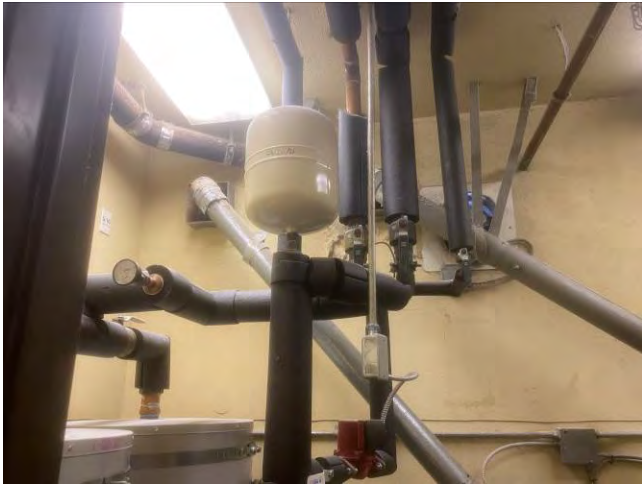
31. Copper water lines observed at two domestic water storage tanks.

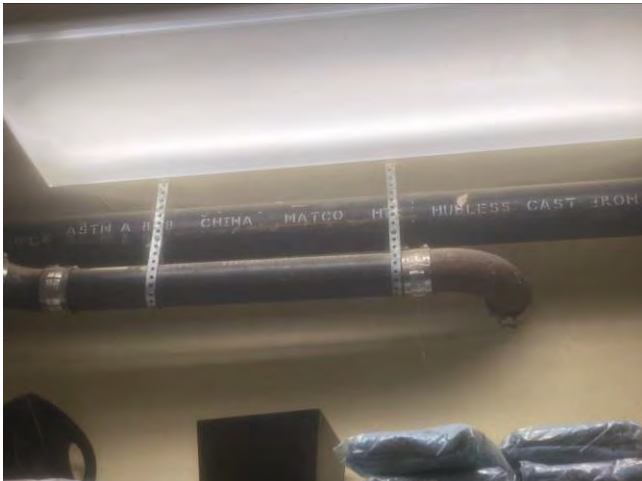
33. Cast iron waste line noted at boiler room.

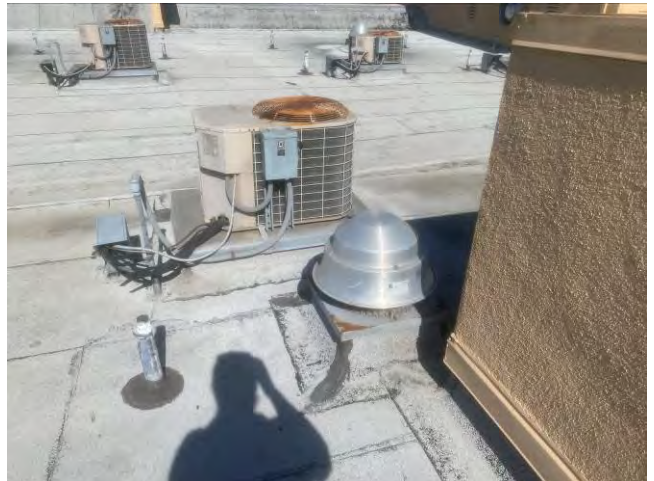
34. The common areas and retail suites are cooled by roof mounted air conditioners. Central exhaust fans are provided for restrooms, corridors, and guest room bathroom ventilation.

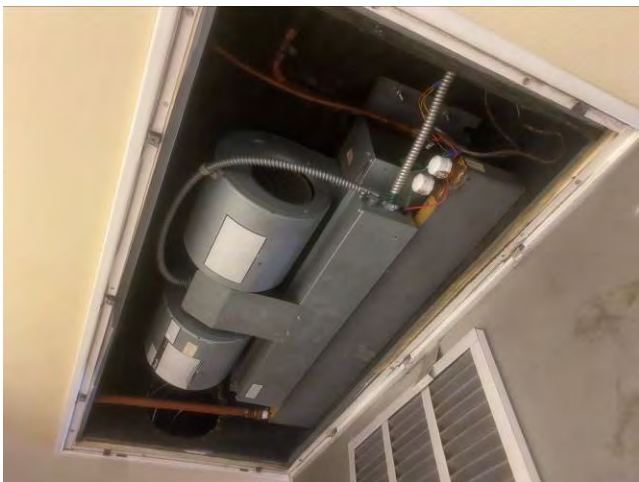
35. Fan coil unit for common area heating and air conditioning.

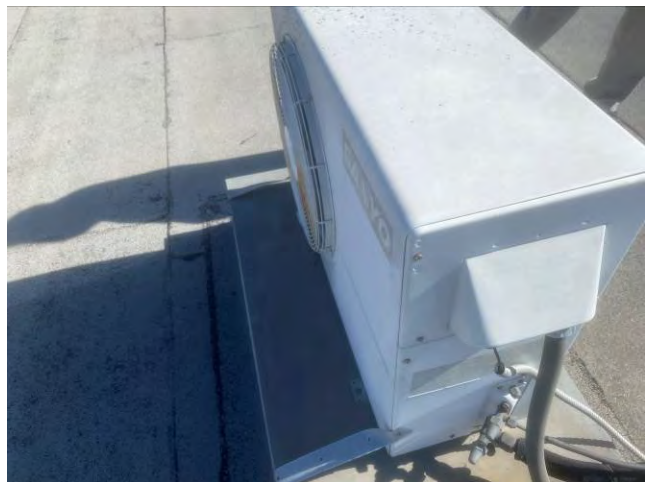
36. Mini split heat pump for the laundry room.

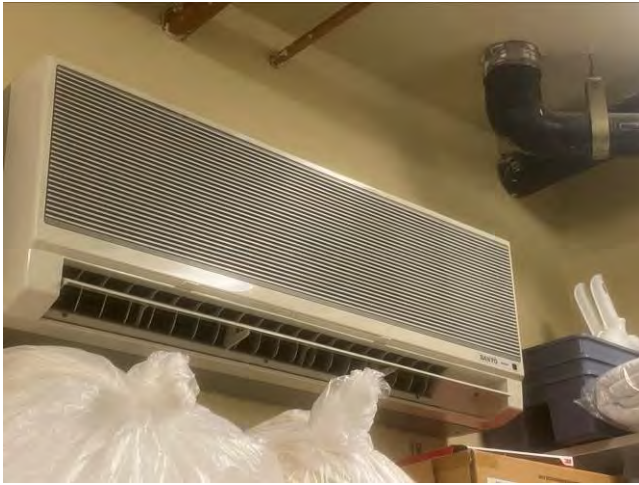
37. Fan for mini split heat pump system in laundry room.

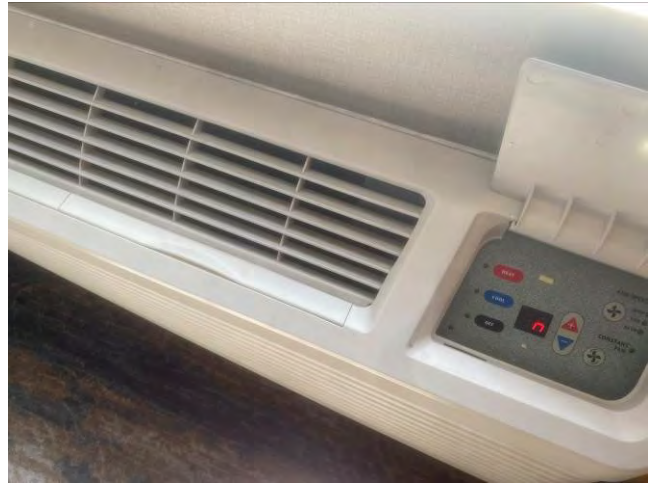
38. Typical PTAC unit for the guestrooms.

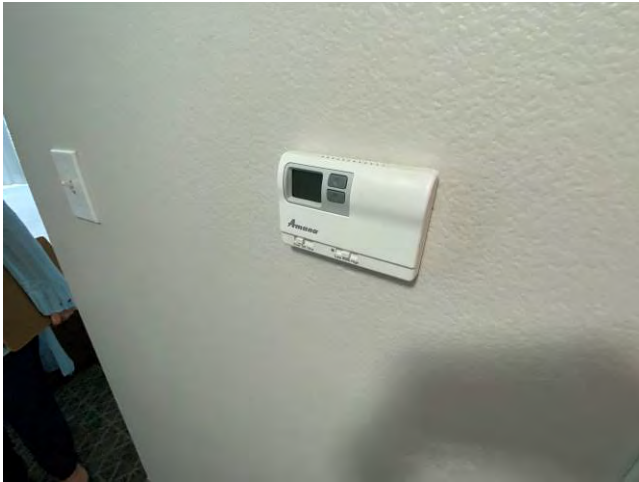
39. Typical thermostat for HVAC control at guestroom.

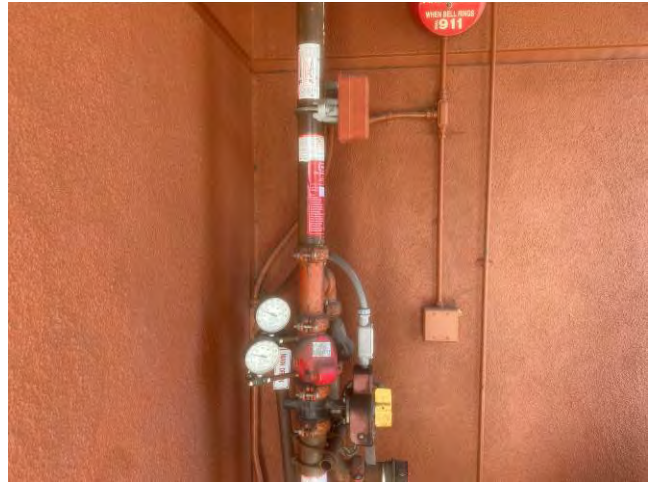
40. Fire sprinkler standpipe with current certification.

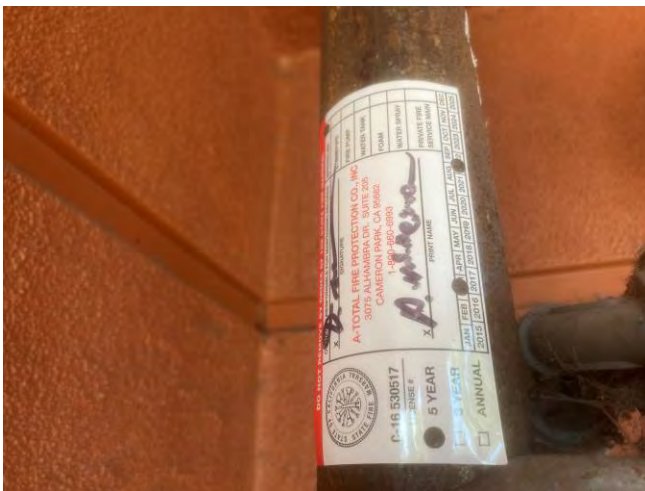
41. Fire inspection tag.

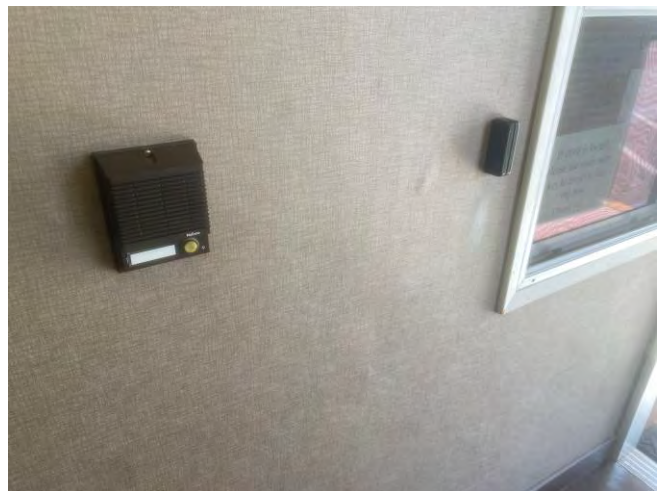
42. Key FOB entry system.

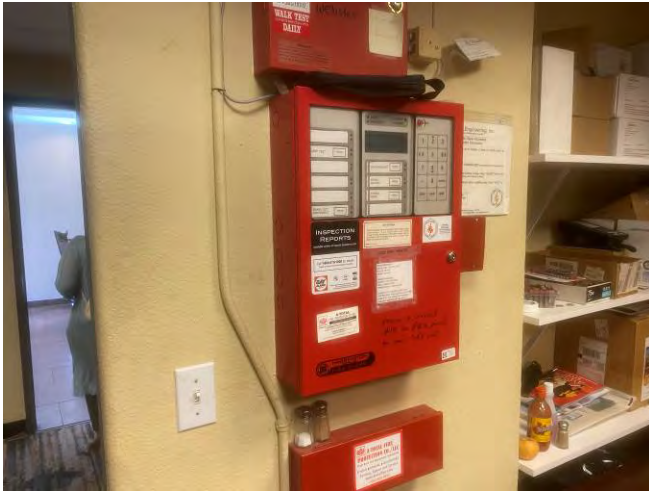
43. Fire alarm control panel.

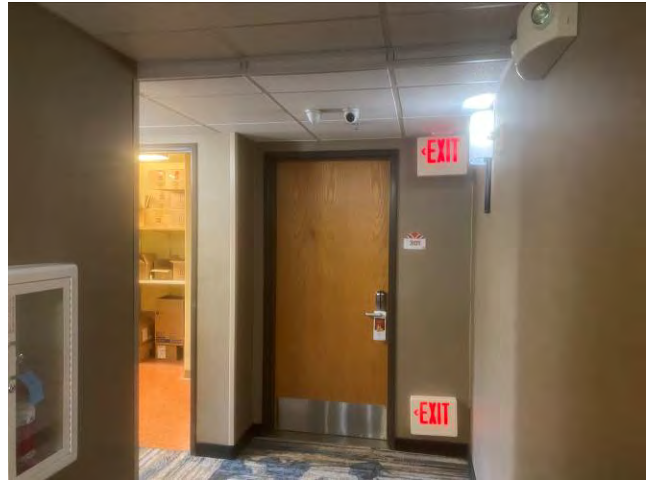
44. Common area life/safety systems include exit signs.

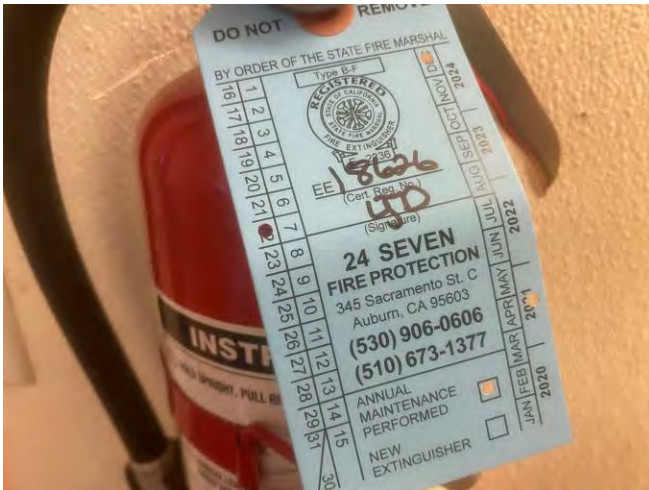
45. Fire extinguisher with current certification.

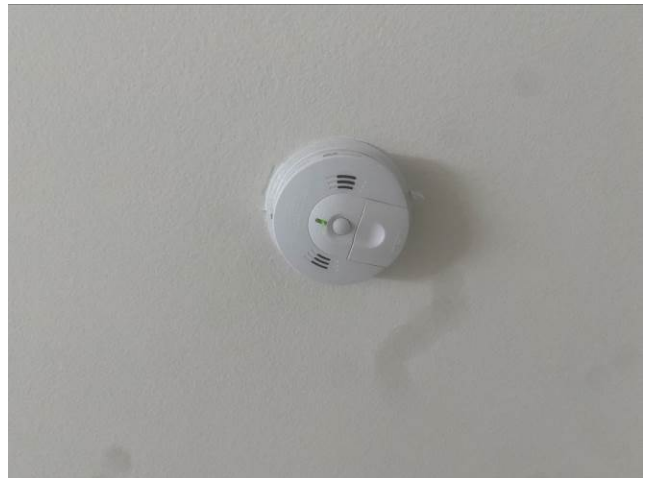
46. Combination smoke and carbon monoxide detector at guest room sleeping area.

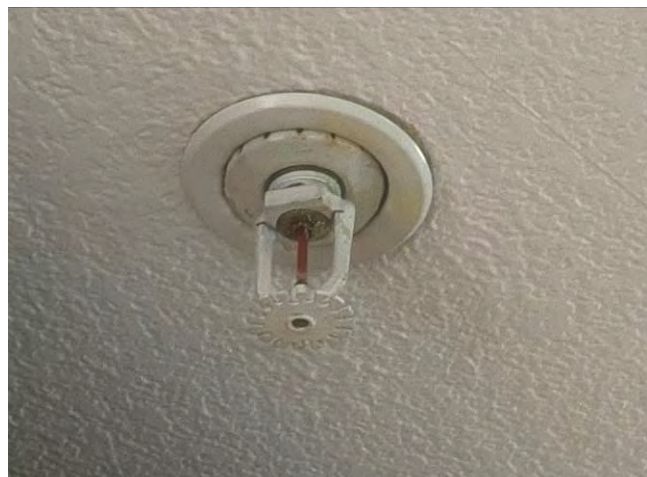
48. Interior mounted fire sprinkler head.

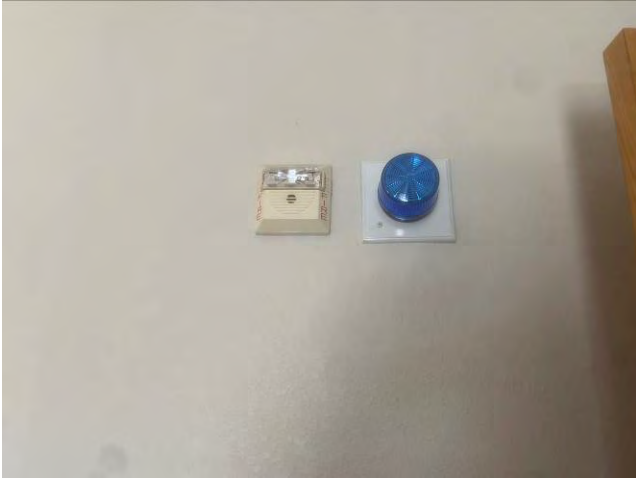
49. Flashing strobe (audible/visual) alarm and hearing impaired devices noted in guestroom 110.

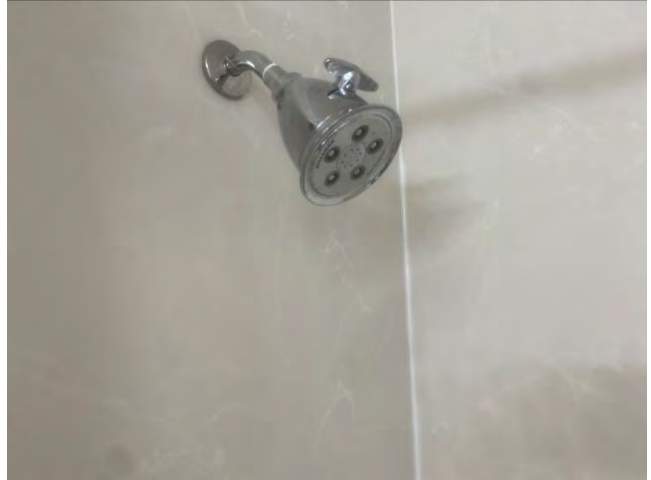
50. Water saving shower heads, faucets and toilets were observed.

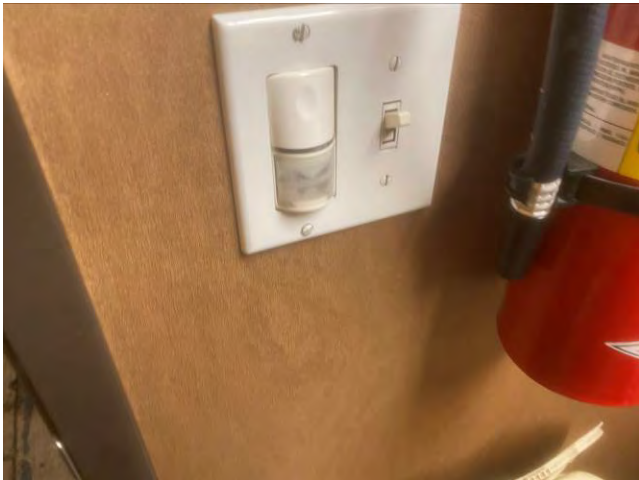
51. Lighting sensors are installed at common areas and guest rooms for energy efficiency.

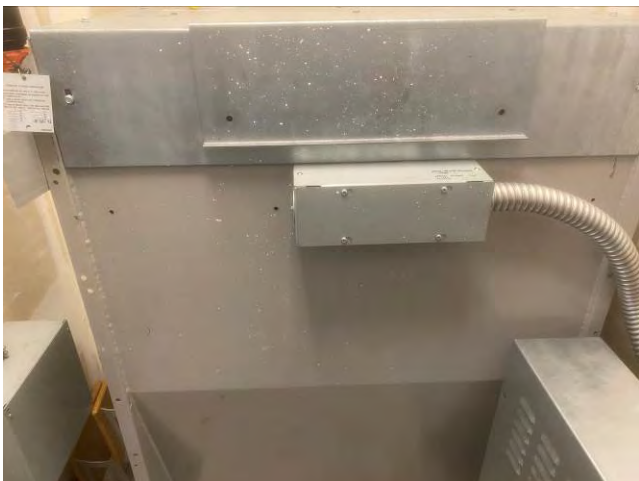
53. Original elevator equipment is maintained under a full service contract.

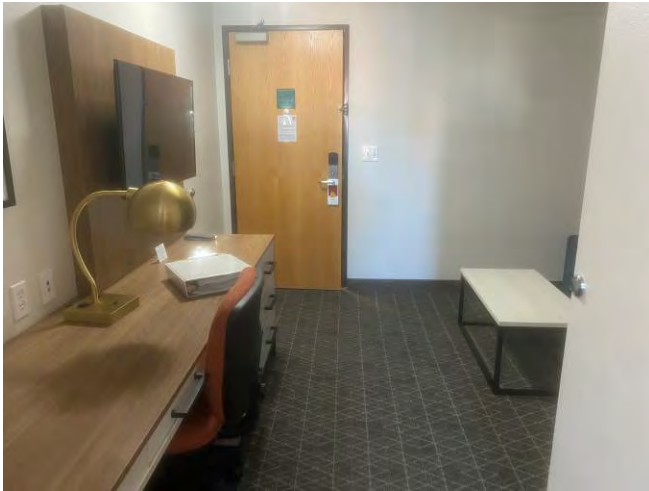
73. Guestroom entry, sitting area and workspace. All finishes and furnishings are newer.

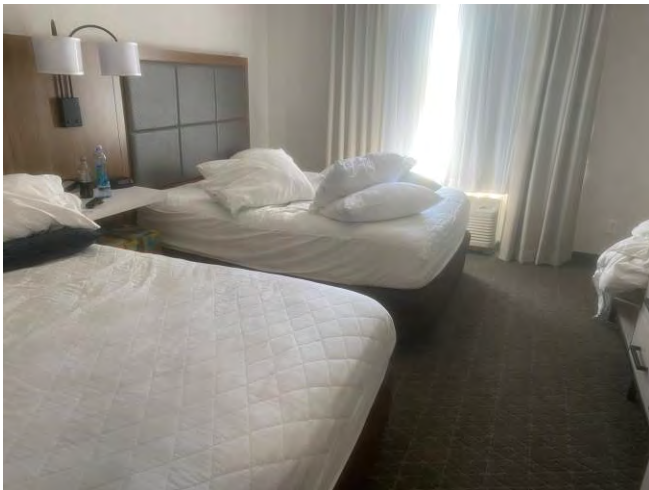
75. Guest rooms have one king or two queen beds. All soft goods and interior furnishings and finishes were recently replaced.

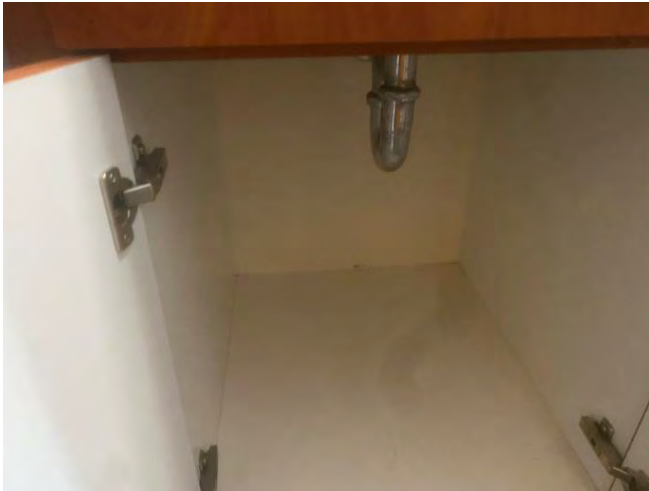
79. Guestroom cabinets are laminated MDF with laminated fronts.
